# Ecolabel testing of the self contained toilet MullToa 60

Tested according to the Nordic Ecolabelling criteria given in the Test method for closed Toilet Systems version 2.4 of 14. June 1999

Jordforsk report nr. 70/04 v2

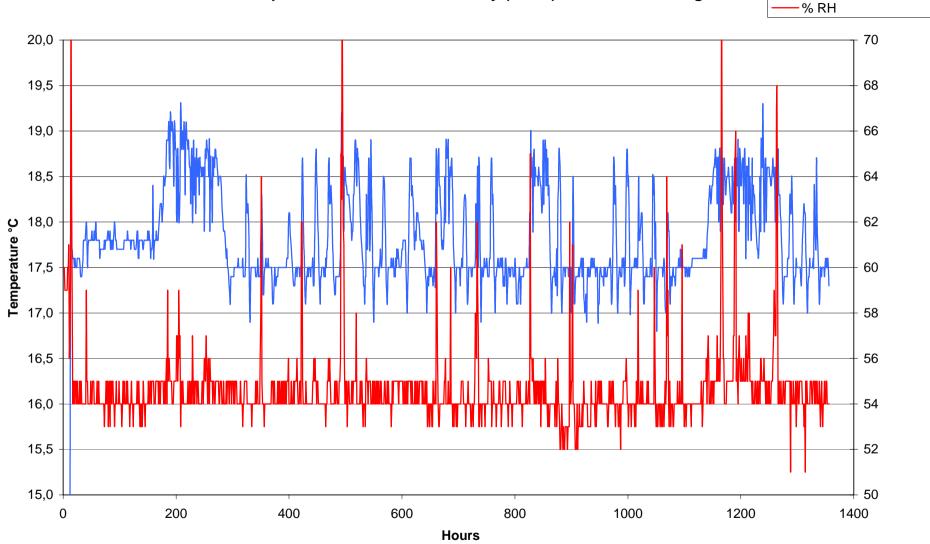
**Appendix 1:** Temperature and relative humidity (RH %) in climate room for function testing

#### Temperature and relative humidity (% RH). Functional testing

----- Room temperature °C ----- % RH

The toilet was tested in controlled climatic rooms at the Centre for Plant Research in Controlled Climate, The Agricultural University of Norway, Ås. The air temperature and relative humidity (RH) were monitored and logged every hour. The temperature was set to 18°C and RH to 55 % during the filling period (Appendix 1). During the composting period the temperature was set to 9°C (Appendix 2).
